An evaluating methodology for hydrotechnical torrent-control structures condition

Ș.O. Davidescu, I. Clinciu, N.C. Tudose, C. Ungurean

Davidescu Ș.O., Clinciu I., Tudose N.C., Ungurean C., 2012. An evaluating methodology for hydrotechnical torrent-control structures condition. Ann. For. Res. 55(1): 125-143, 2012.

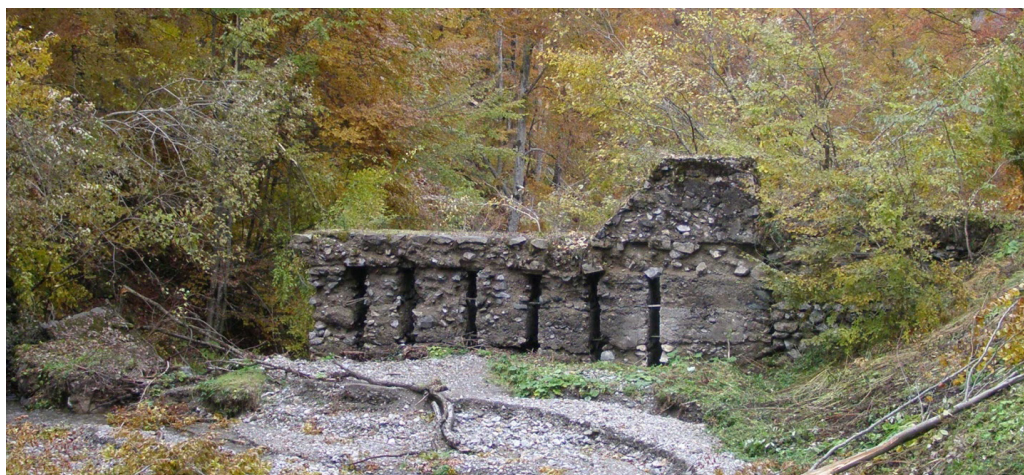
Figure 2 Multiple damages (wall wing and spilled area breaking, body abrasions, guarding wall breaking etc.) occurred during the exploitation of dam 90MF6.0 placed on the riverbed of Lungsor stream (Crişul Repede Watershed)

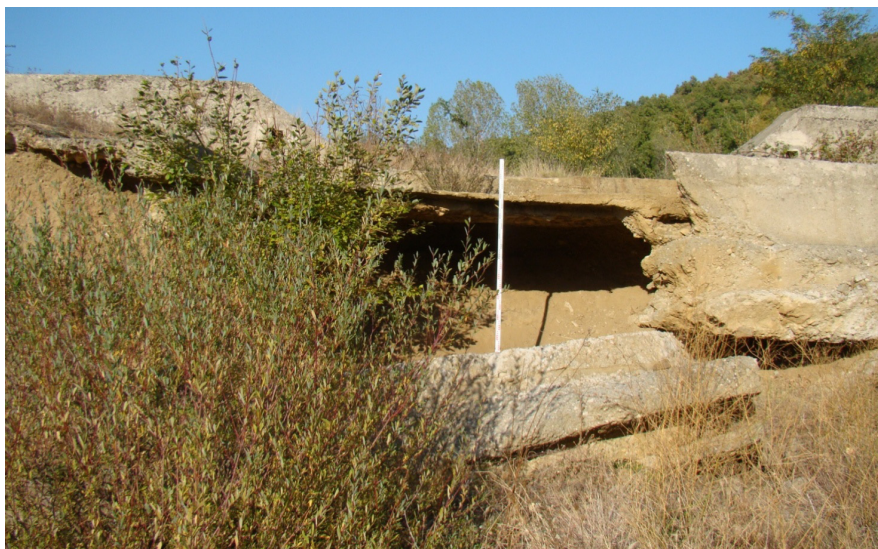
Figure 5 Apron undermining affecting 10% of the apron, having a depth of 3.0 m and an intensity rate of 0.3 of the structure 30B0.5 located on Bremenea Valley (the direct slopes of Danube)

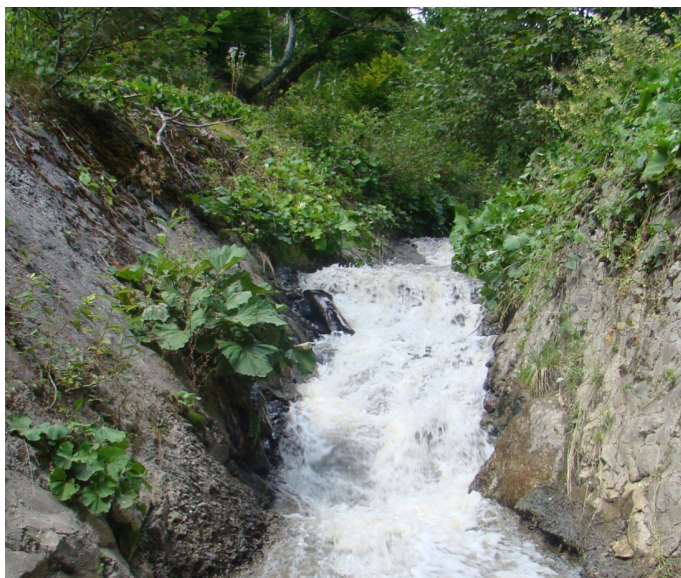
The low gradient of regression line is explained by the good condition of drain channels 50 – 60 years old, in that situation being reported 13 drain channels built using cement

mortar masonry, part of them being repaired during 1975 – 2005 (Figure 12).

Figure 12 Drain channel 10KM137 on Plaic Stream (Tisa Watershed) built on 1965 and repaired on 2005
